# DetaClad™ Characterization for High-Temperature and High-Pressure Hydrogen Service

**PVP2022-80639**

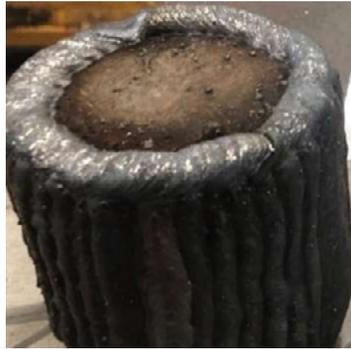
**Figure 4:** ASTM G146 Specimen Weld Overlaid on the Edge

The sides of cylinders were cladded to prevent hydrogen from escaping. To accomplish this cladding, gas metal arc welding (GMAW), was employed to WOL the coupon blanks and put a top seal between the EXW and the sides as shown in Figure 4.

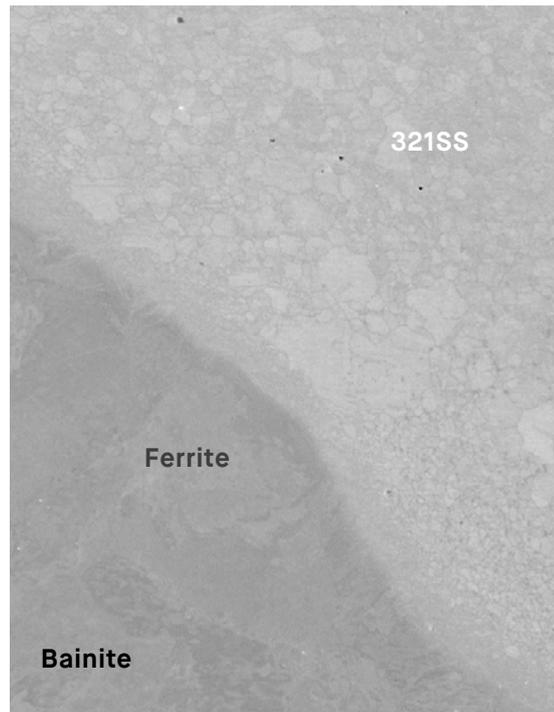
**Figure 11:** SEM of metallography of interface - As cladded specimen

The head forming plus LPWHT specimen (Figure 11) exhibited a layer of ferrite at the interface that can be explained by diffusion/migration of carbon into the stainless-steel matrix during the heat treatment. The lower shear value reported in Table 6 is potentially one consequence of the presence of that ferrite layer. The presence of ferrite was confirmed by the Vickers microhardness measurements presented in Figure 12.

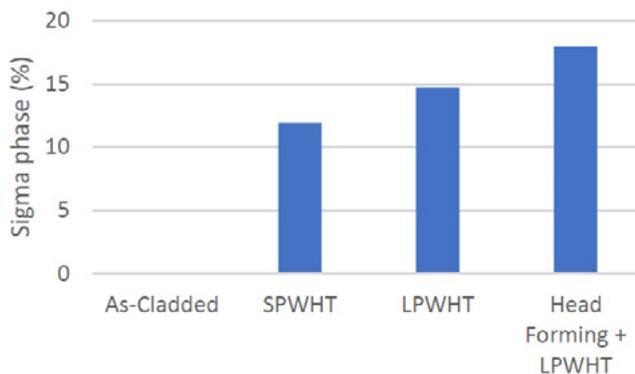
**Figure 13:**  
Estimate sigma phase fraction in the AISI 321 cladder near the interface

Referring to the prediction methods of the Sigma ( $\sigma$ ) phase [8], the ratio factor based on chemical composition of the cladder is equal to 1.7, which is favorable for the appearance of the  $\sigma$ -phase. The  $\sigma$ -phase has a detrimental impact on both the mechanical and corrosion resistance properties of the cladder. Analysis was conducted on 4 specimens that underwent different heat treatments. Results are shown in Figure 13.
